Village of Bellevue

Multi-Department Existing Building Analysis & Space Needs Study

MAY 4, 2018
FINAL REPORT

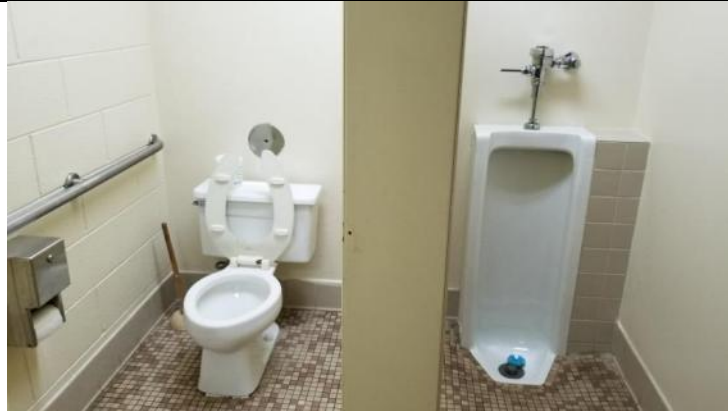
ADA compliance issues in the men's and women's toilet rooms include wheelchair turning radius, grab bars, accessible stalls, and door push pull clearances. ADA upgrades are required to be made if other building improvements are made. 20% of any project budget needs to be spend on ADA upgrades until the building is brought into compliance

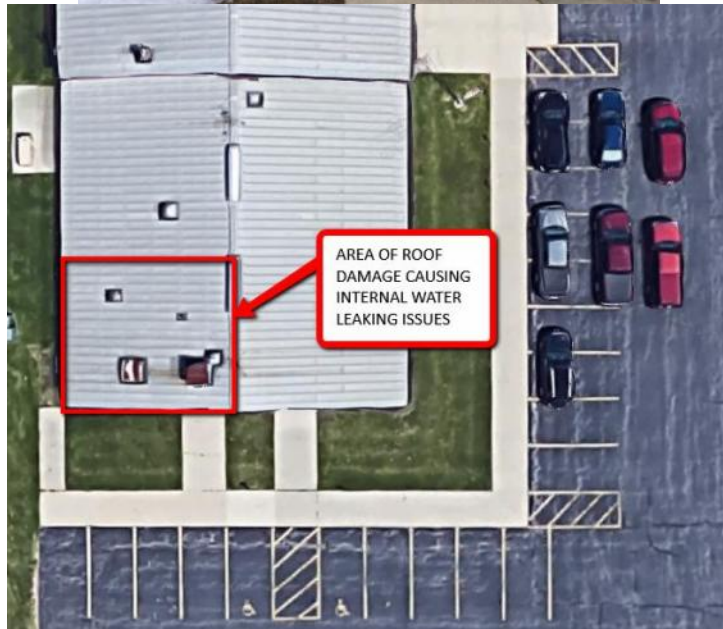
The building envelope is in moderate condition for its age however it is important to remember that the typical lifespan of a metal building used for Fire/DPW functions is 40 to 50 years. The lower roof has experience some damage in storms over the last few years and since the style of roof is no longer made, roof patches have been completed, however the roof does still leak and is causing damage to the building interior. Some signs of wear to the metal finish can be seen on the roof, canopy and doors. On-going maintenance items should include caulking, painting and refinishing exterior hollow metal doors. A building of this age will likely have unexpected repairs over the next 5 years that we are not calling for in our maintenance budget simply due to the age of the facility.

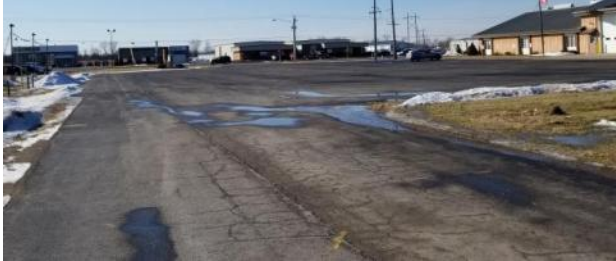
<p>Standing water and surface cracking was observed throughout the parking and drive lanes on site and will likely be in need of full replacement in the next 5 years.</p>

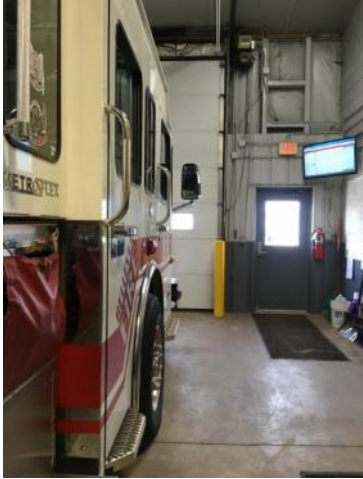
<p>Backing large vehicles into the Apparatus Bays is difficult due to narrow overhead doors. Bollards and skillful driving for the most part have prevented damage to either the vehicles or the overhead doors however wider overhead doors and a drive thru condition, where no backing up is required, is a preferable setup for a Fire Apparatus Bay.</p>

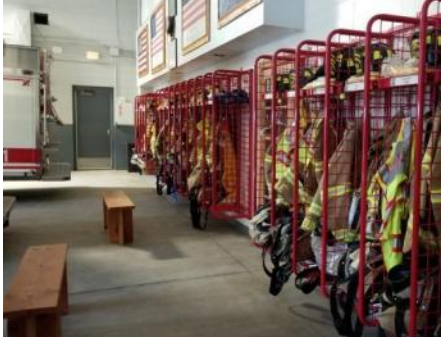
<p>Turn-out gear is located on the back wall of the Apparatus Bays and leaves little room for firefighters to put on their gear and maneuver around one another during prior to leaving on a call.</p>

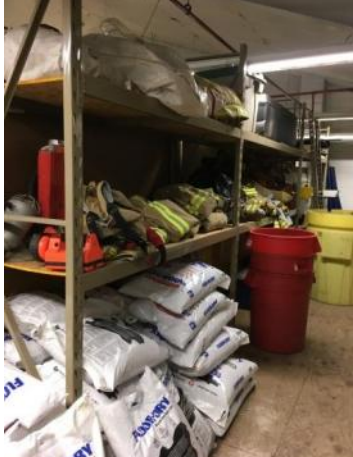
<p>The mezzanine in the Fire Apparatus Bays does not have a gate heavy/bulky items being stored here are required to be carried up and down the stairs as needed.</p>

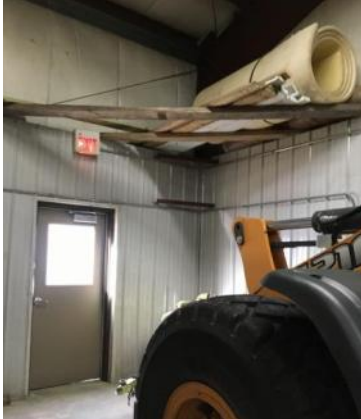
<p>Storage is being added in unconventional locations due to lack of storage space and in this case could be an issue if overloaded.</p>

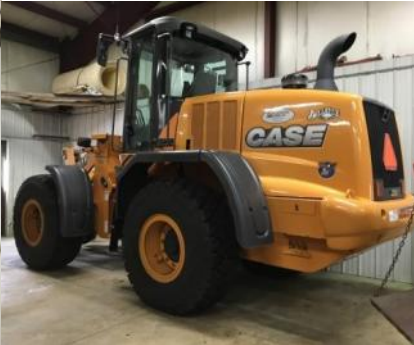
<p>Vehicles are parked within an inch or two of walls and building structural columns with no bollard protection. One small mistake when parking these vehicles so tightly against the building could cause significant damage to the DPW Storage bays.</p>

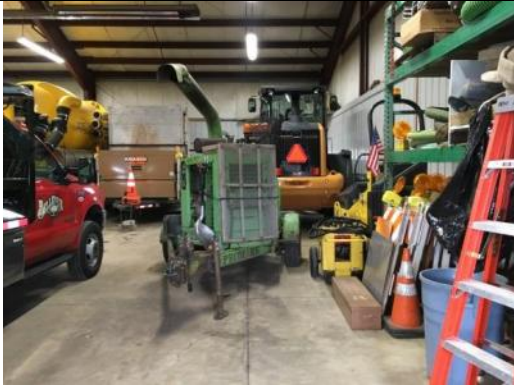
<p>Interior storage space of vehicles, parts and equipment is extremely limited and almost always requires moving multiple pieces of equipment to gain access to the vehicle or equipment that is needed. Operational efficiency is sub-standard</p>

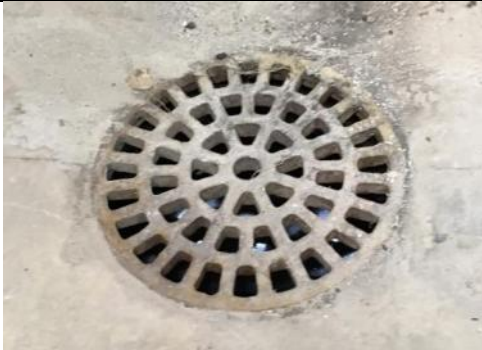
<p>Floor drains frequently don't drain because of too much sediment coming off of trucks. Many hours are spent by staff cleaning these. Repairs should be made to these drain locations.</p>

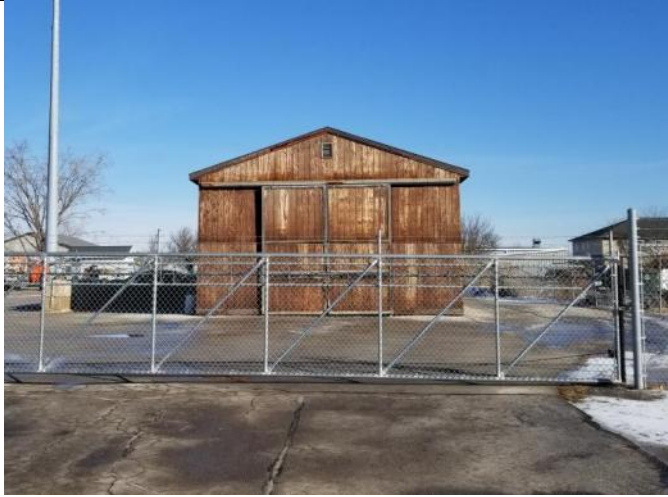
Salt Shed is undersized at 200 Tons of Salt Storage and the interior roof structure has been damaged when loading salt which has led to structural issues including leaning and bulging walls. The salt storage building is undersized and is in need of replacement. Determining a location for a new salt shed is important and should be included as part of a master plan for the DPW. If the Village had a larger shed then all the salt needed for the year could be ordered when prices are low and would save the Village from having to order when out of salt. On occasion salt is unavailable for purchase at the end of a season and diminishes department's ability to serve the Village's residents.

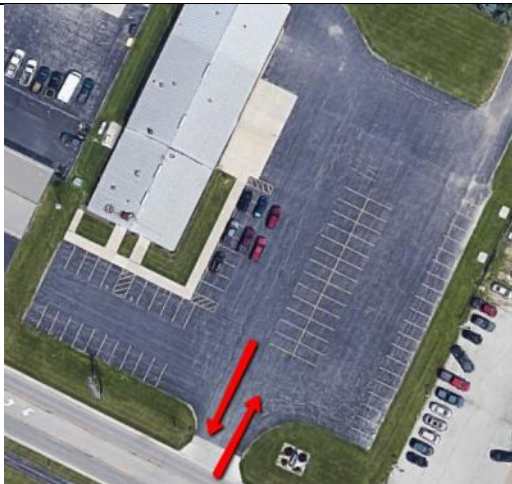
The existing site only has one access point. During community events navigating the parking lot with Fire vehicles is difficult. It also has the possibility of delaying a response time if an event is letting out at the same time as a call.

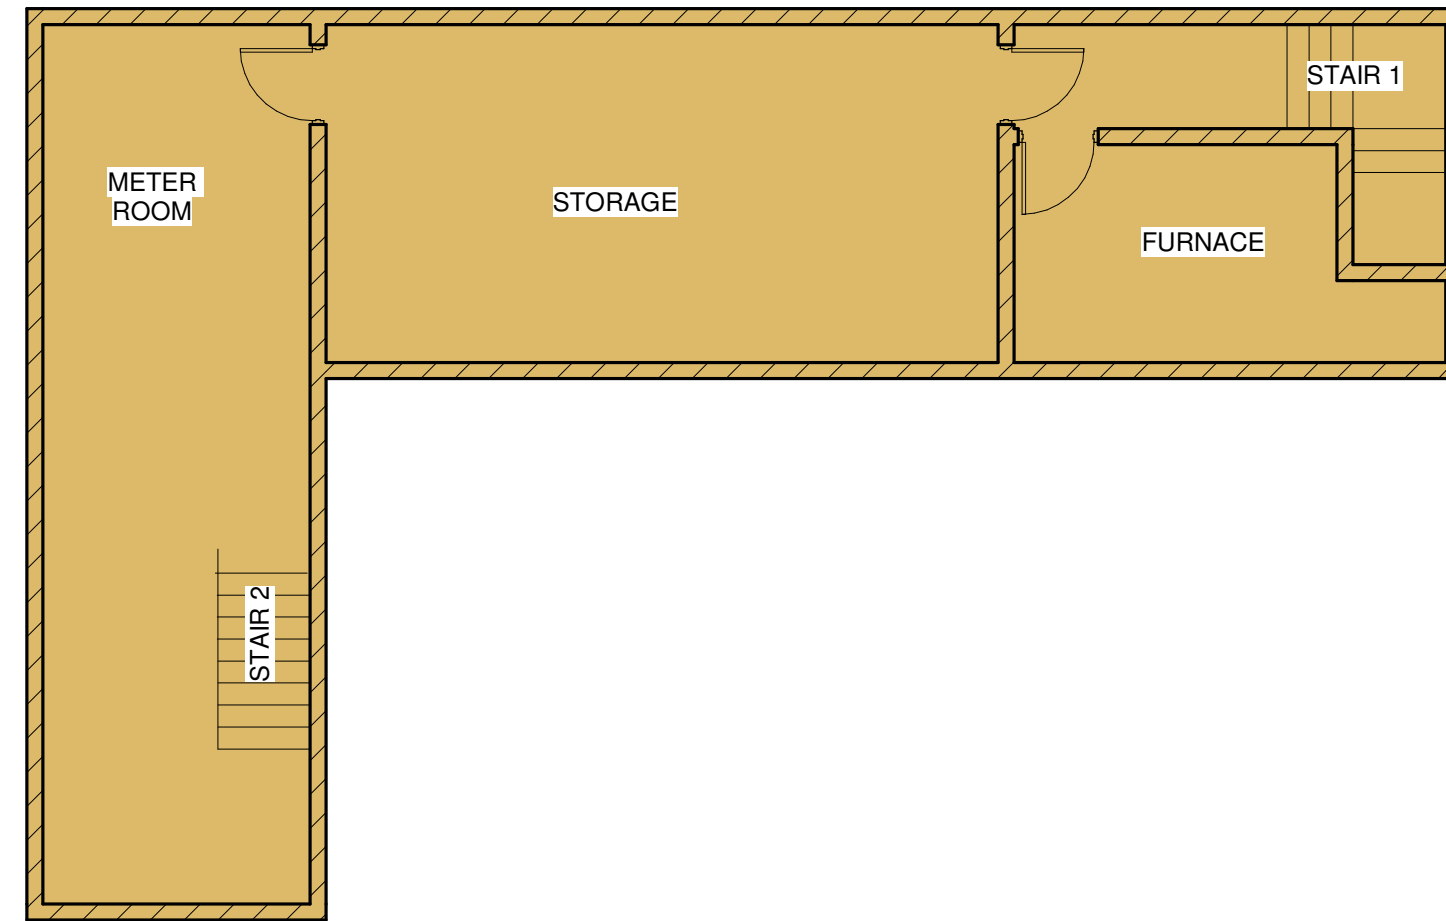
EXISTING BUILDING DEPARTMENT PLAN

FIRE	4,684 SF
	DPW	2,890 SF
	RECREATION	2,512 SF
	SHARED SPACE	2,127 SF

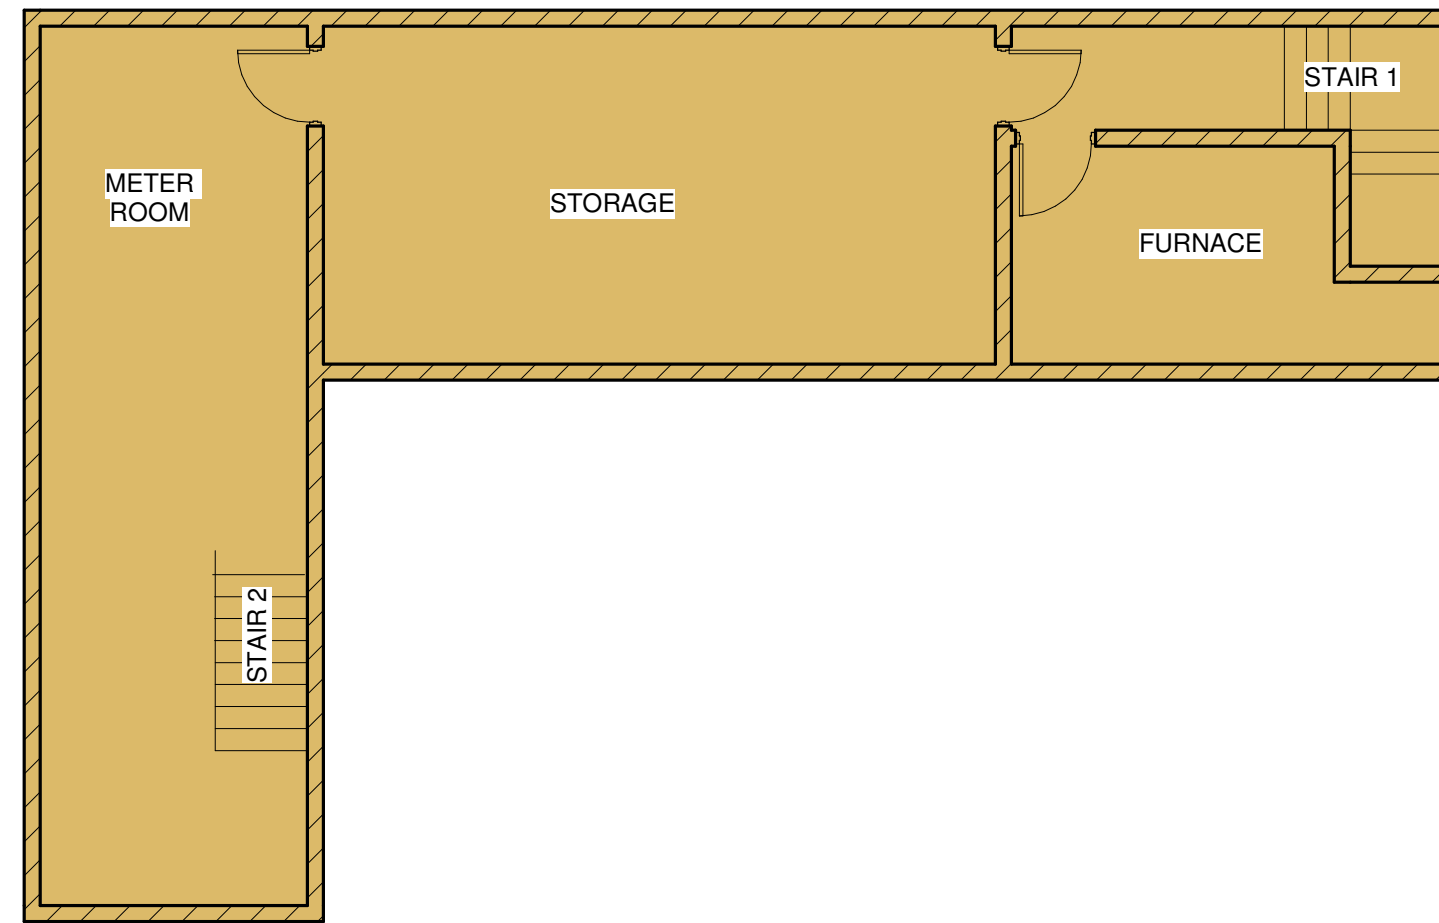
NEW FIRE, RENOVATED RECREATION, RENOVATED DPW

FIRE	NEW LOCATION
 DPW	7,400 SF INCLUDING MEZZANINE
 RECREATION	3,500 SF
 SHARED SPACE	1,300 SF

In this option the Fire Department, which is undersized and does not have the ability of house full time staff or have drive-thru bays, is relocated to a new building on a yet to be determined site. In Tab 8 there is an optimal floor plan for this new facility and a hypothetical site plan that was developed to assess the required acreage that would likely be needed for a new fire station building.

The existing location would be renovated for use by the DPW and Recreation Department. This option would resolve the building maintenance issues for each department but the DPW and Recreation departments still would have concerns regarding long term space needs and the location of this facility. The DPW Yard would remain in its current location however a study should be completed on the DPW department as a whole to determine exactly where they should place a new Salt Shed so that it fits into a long term master plan for the department.

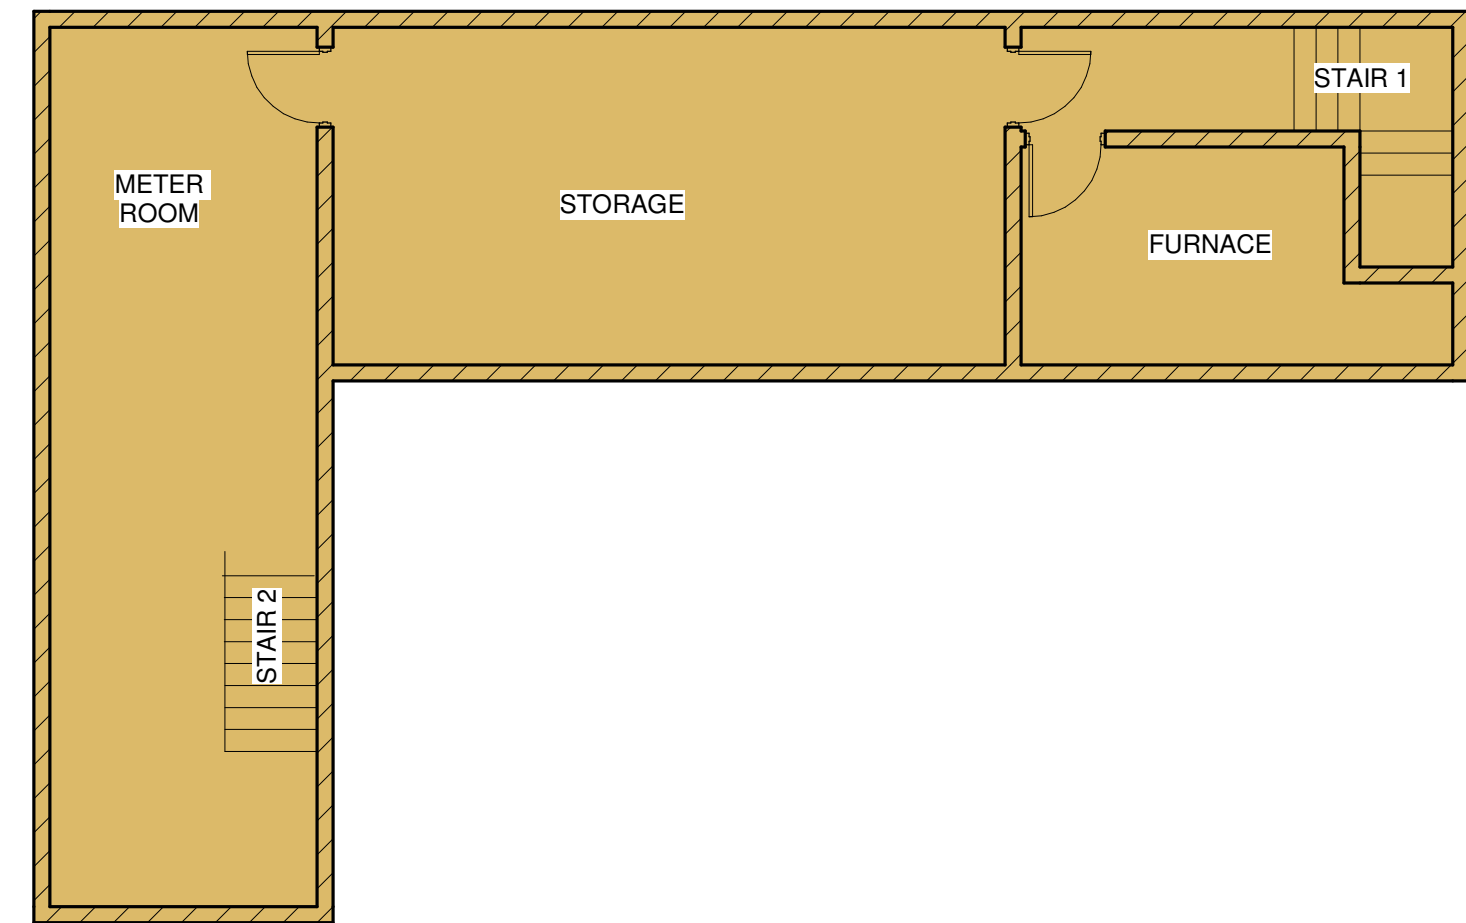
NEW FIRE, NEW COMMUNITY CENTER, RENOVATED DPW

FIRE	NEW LOCATION
 DPW	7,575 SF INCLUDING MEZZANINE
 RECREATION	N/A
 SHARED SPACE	4,625 SF

This option would handle the deficiencies of the Fire and Recreation Departments with the design of two new buildings however the DPW would still be operating out of a facility that has a structure that is approaching 50 years or age and does not fully meet their needs.

This option also frees up 4,624 square feet in the front of the 1811 E. Allouez Avenue building, currently used by the Recreation Department, for another Village function. This is shown as "Shared" square footage at the moment and could be used for many different Village purposes including Village Offices, Storage, or Meeting space.
